Development of Inspection Technology for NGV Fuel Tanks

Failure Analysis Associates, Inc.
Menlo Park, California

General Motors Corporation
Research & Development Center
Warren, Michigan

May 1997
(Revised August 1997)

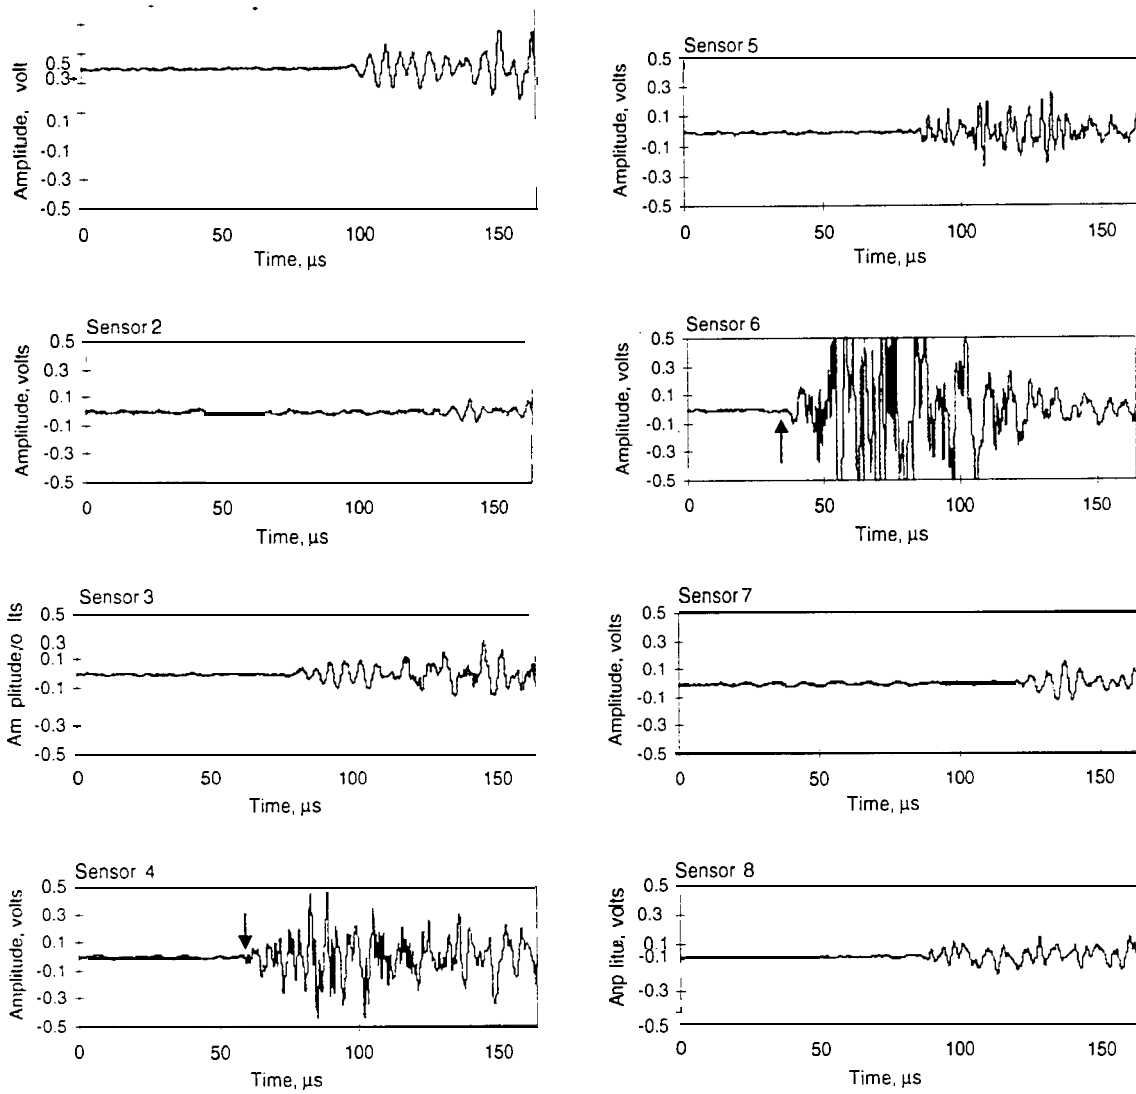
typical waveform attributed to the over-wrap in an as-received Type 2 tank is shown in Figure 88. The arrival times, indicated by the arrows, suggest that the source for the acoustic emission is on the bottom of the tank, between sensors four and six. The FFT of the waveform, shown in Figure 88b, exhibits a broad low frequency content to 500 kHz but little high frequency content above 1 MHz. Another typical waveform recorded during pressurization of an as-received Type 2 tank is shown in Figure 89. The signals shown in Figures 88 and 89 are representative of the signals associated with the response of the over-wrap. No waveforms were recorded with significant high frequency content, which is characteristic of fiber breakage. Visual inspection of the tanks after initial pressurization revealed that the autofrettage cracks were more prominent. This observation combined with the acoustic emission data support the conclusion that the acoustic emission events obtained during pressurization of as-received Type 2 tanks were generated by matrix cracking.

Figure 88a. Waveform from a Typical Structural Event Recorded During Pressurization of the As-Received Type 2 Tanks

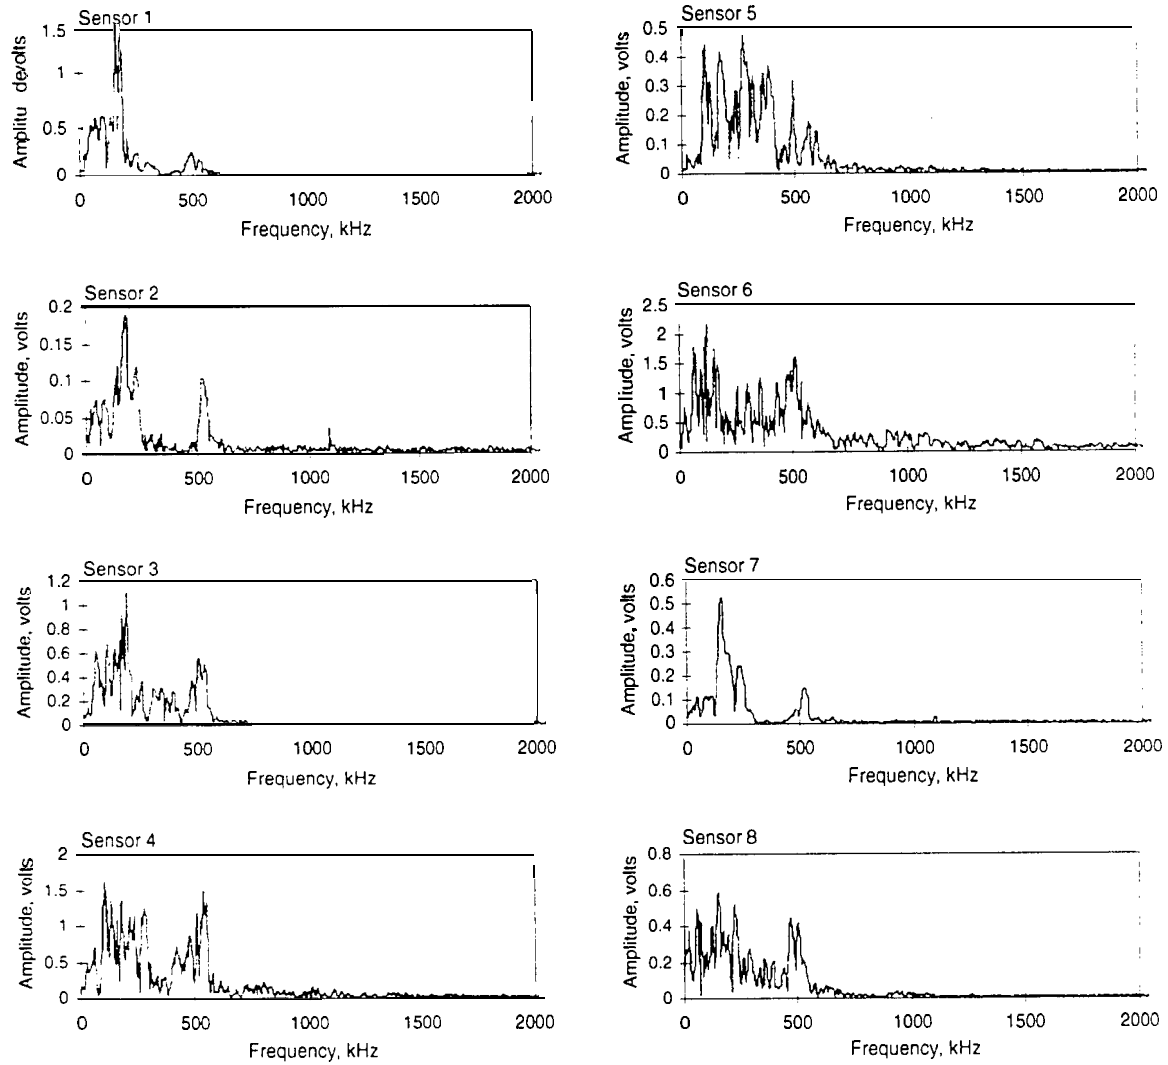
Figure 88b. FFT from a Typical Structural Event Recorded During Pressurization of the As-Received Type 2 Tanks

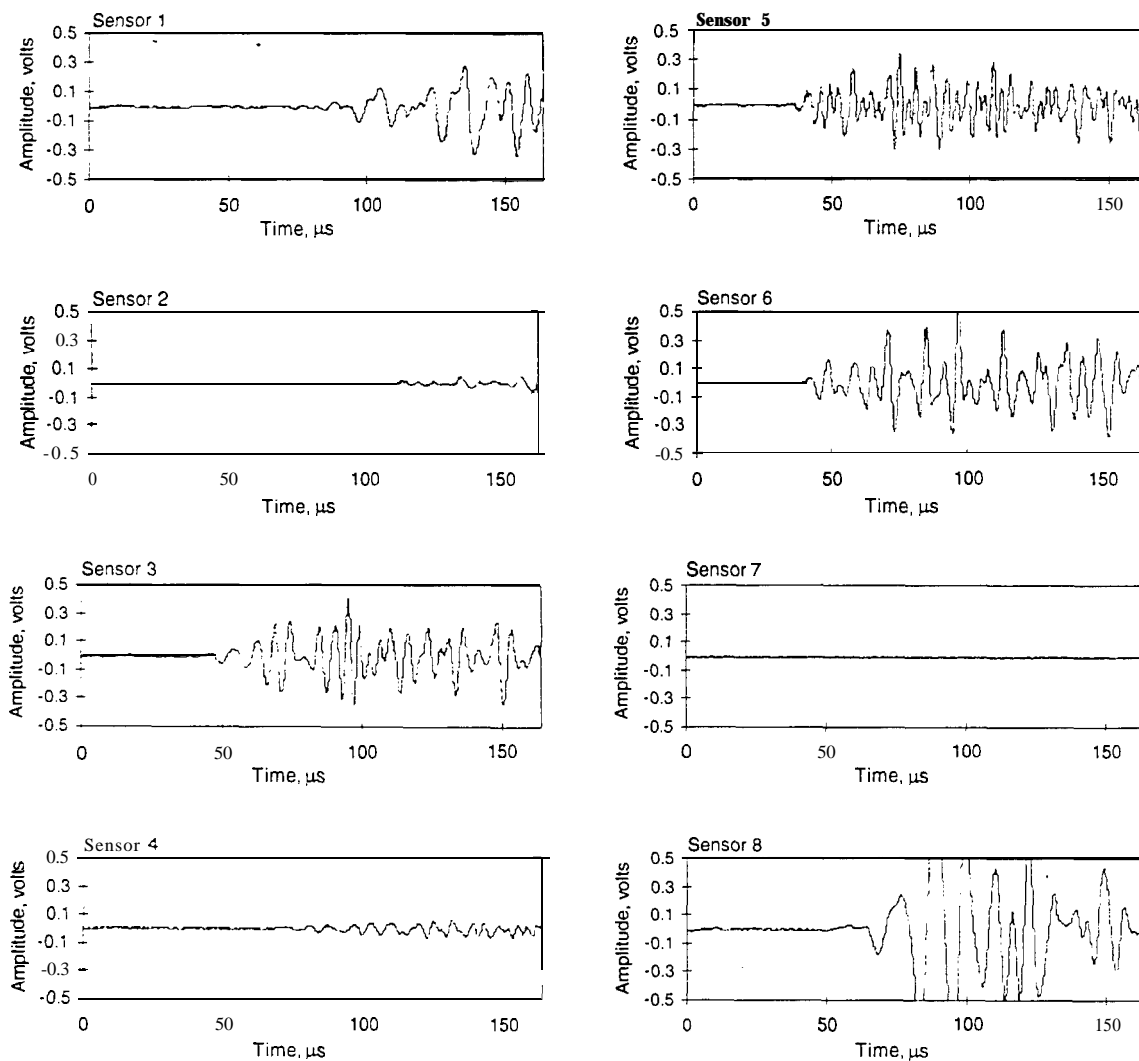
A typical waveform and FFT from pressurization of the as-received Type 4 tank is shown in Figure 90. As with the Type 2 tanks, the recorded acoustic emission events were consistent with matrix cracking. No waveforms with high frequency components characteristic of fiber breakage were obtained.

Figure 90a. Waveform from a Typical Event Recorded During Pressurization of the As-Received EDO Type 4 Tank

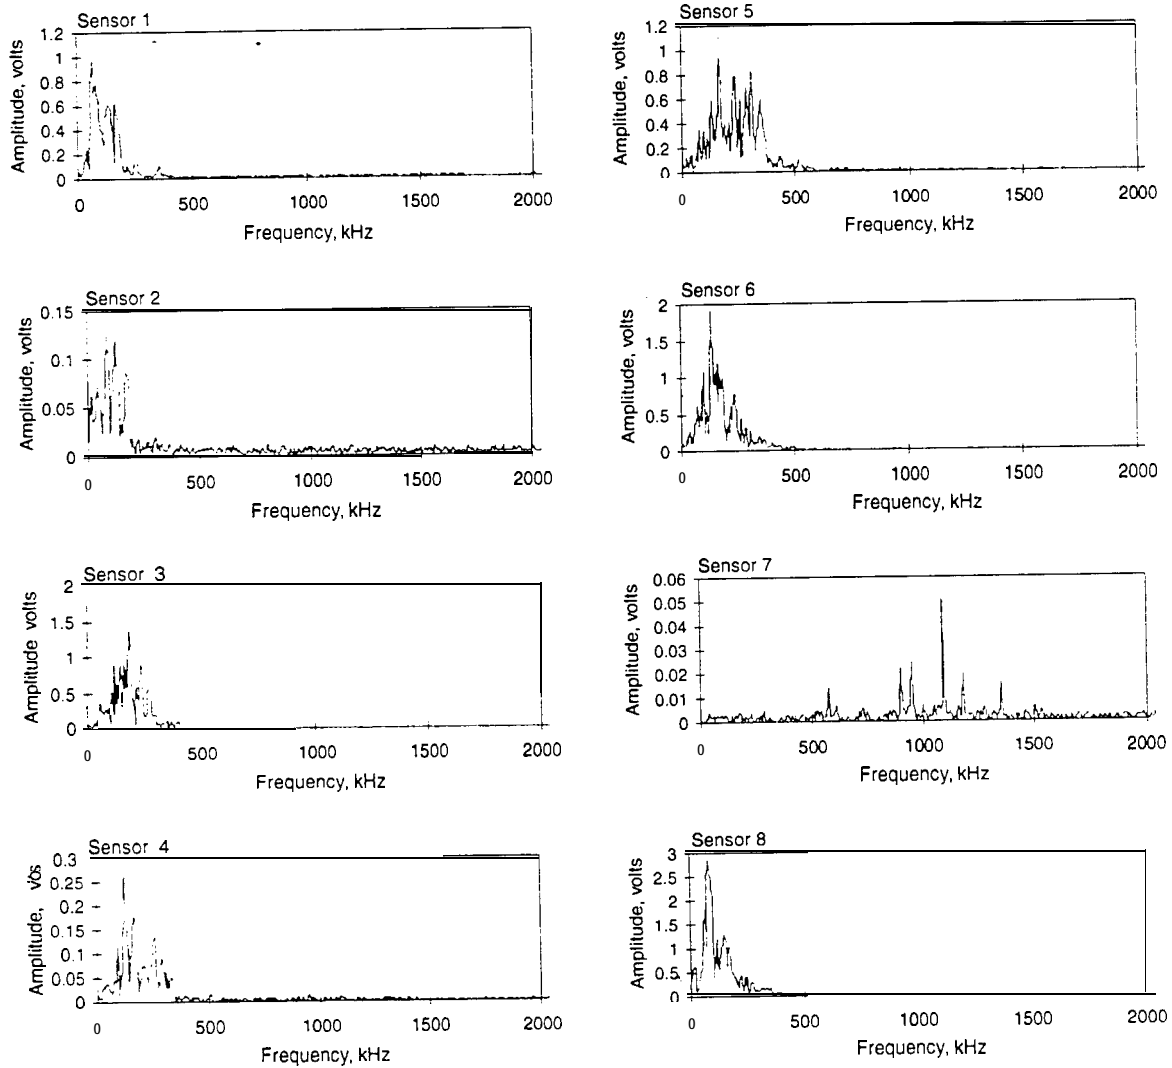
Figure 90b. FFT from a Typical Event Recorded During Pressurization of the As-Received EDO Tank

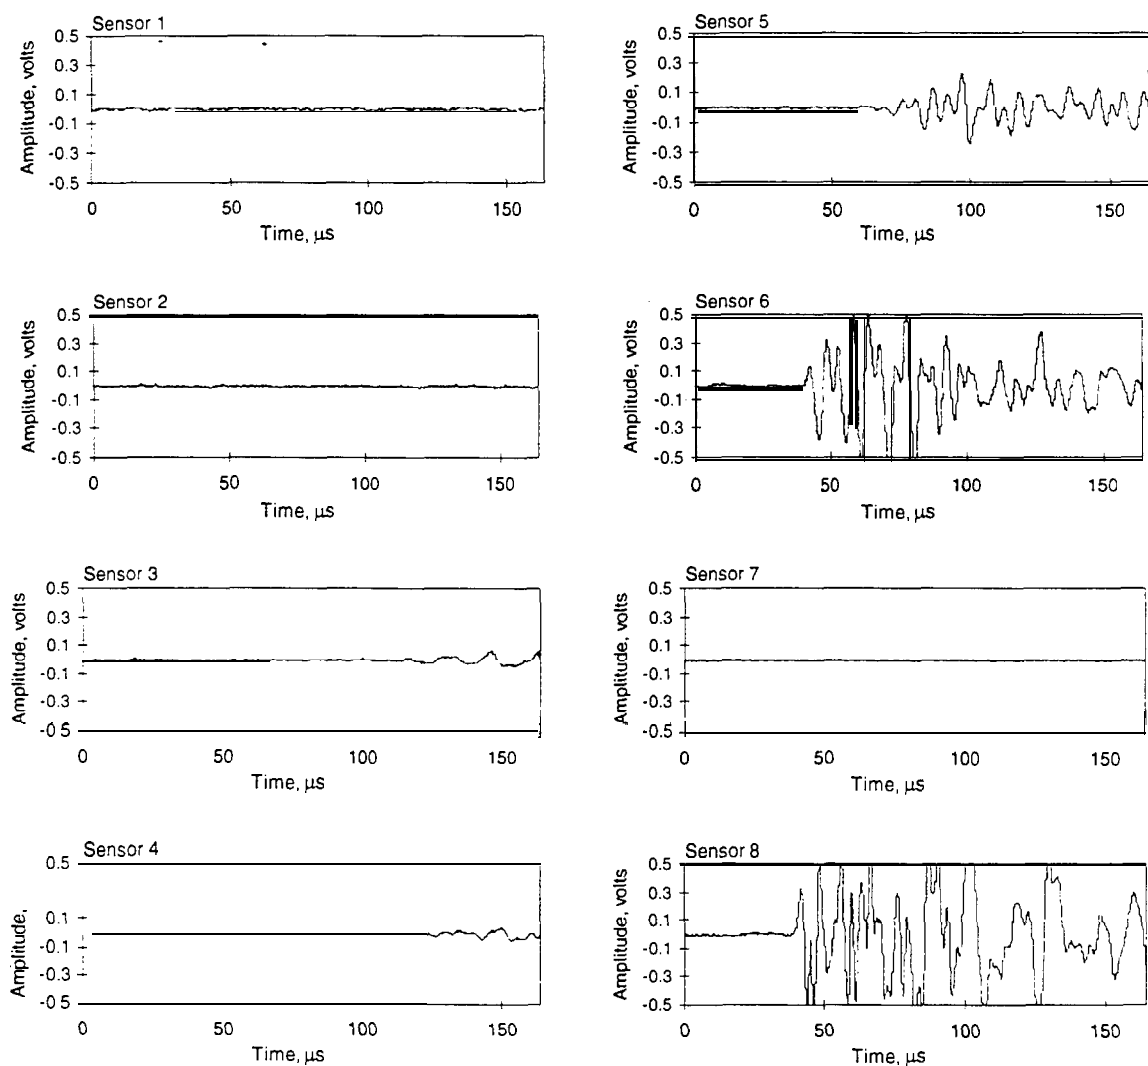
A typical waveform produced during the pressurization of the damaged Type 4 tank is shown in Figure 93. The impact damage area was identified as the primary source of acoustic emission events during the post-damage pressurization. Over 80% of the signals recorded originated in the damaged area. No high frequency waveforms indicative of fiber breakage were recorded. Visually, no changes were observed in the damaged Type 4 tank following pressurization. However, matrix cracking could have occurred within the overwrap without being detected on the surface of the tank.

Figure 93a. Waveform from a Typical Event Recorded During Pressurization of the Type 4 Tank with Impact Damage

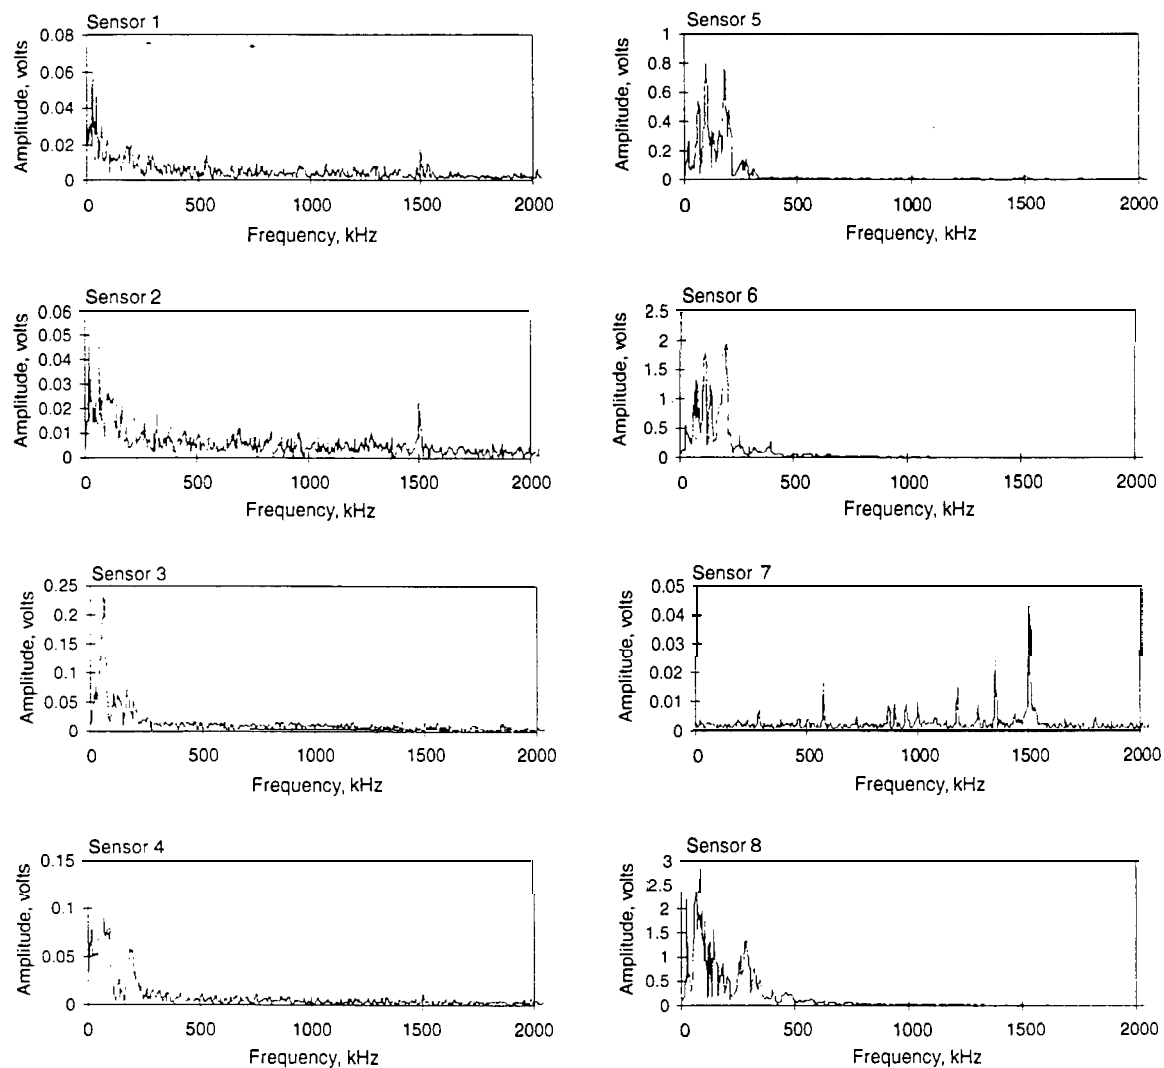
Figure 93b. FFT from a Typical Event Recorded During Pressurization of the Type 4 Tank with Impact Damage

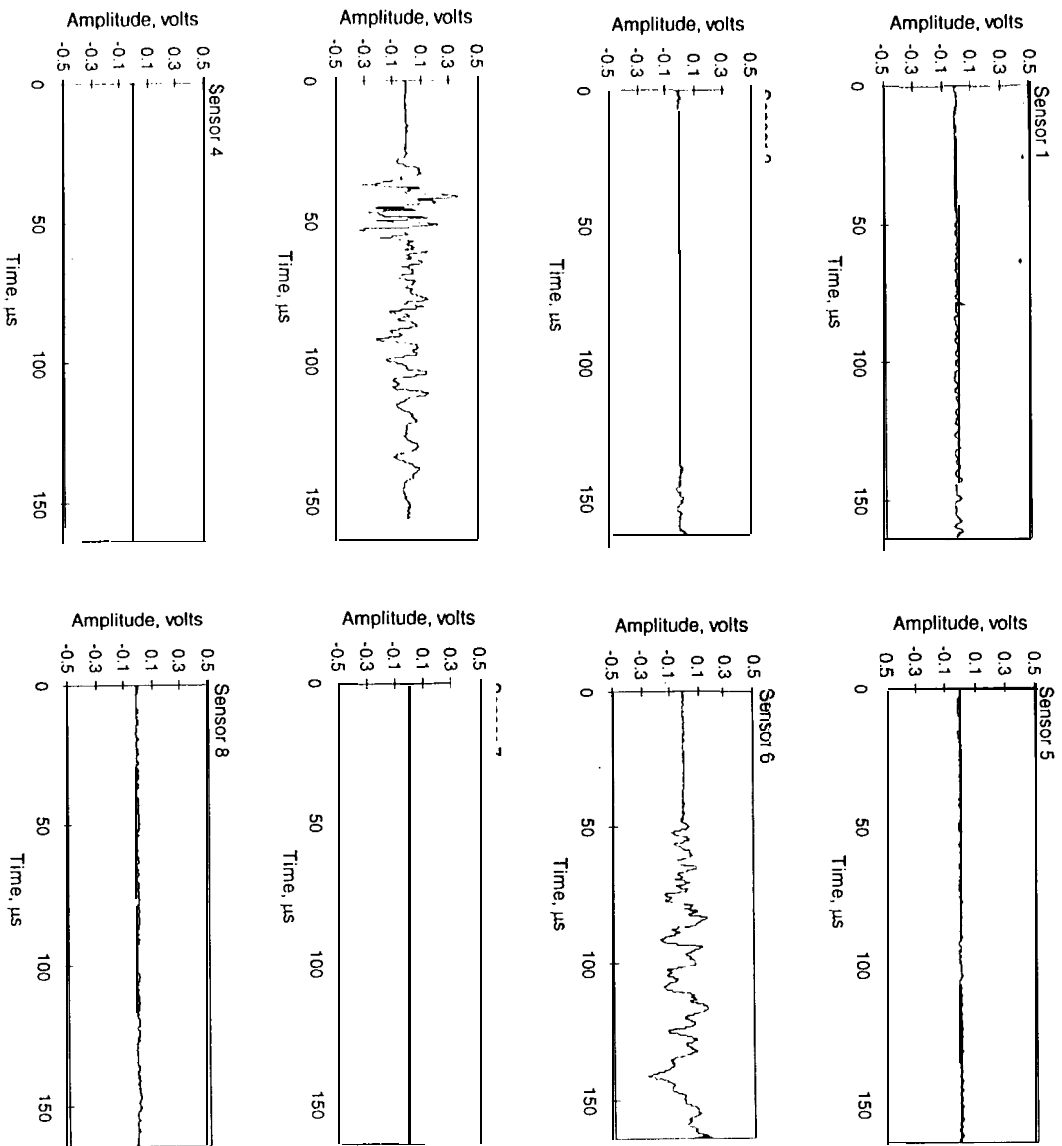
Tanks were subjected to cyclic pressure loading to determine the effect of repeated pressurizations on damage growth and lifetime. Acoustic emissions from Type 2 tanks included a large number of fretting and rubbing events. A typical fretting event signal, which is characterized by long duration and low frequency components, is shown in Figure 94. This signal was identified as a fretting event, in part, because of the number of times that it was repeated during the fatigue testing. In some cases, the identical waveform was generated in the over-wrap during more than 50 consecutive fatigue cycles. Physically, fretting was associated with crack growth in the damaged area, as cracked and delaminated surfaces of the overwrap plies rubbed against each other. A signal from a noise event, which was also repeated over a large number of consecutive pressurization cycles, is shown in Figure 95. Acoustic emission events, similar to those shown in Figures 88 and 89, were interspersed in the noise data and attributed to matrix cracking. No signals indicative of fiber breakage were found in the acoustic emission during fatigue testing of the Type 2 tanks. The acoustic emission events indicated that fretting and matrix cracking were the primary mechanisms of damage growth during fatigue testing.

Figure 94. Waveform from a Typical Fretting Event Recorded During Fatigue Cycling of a Type 2 Tank

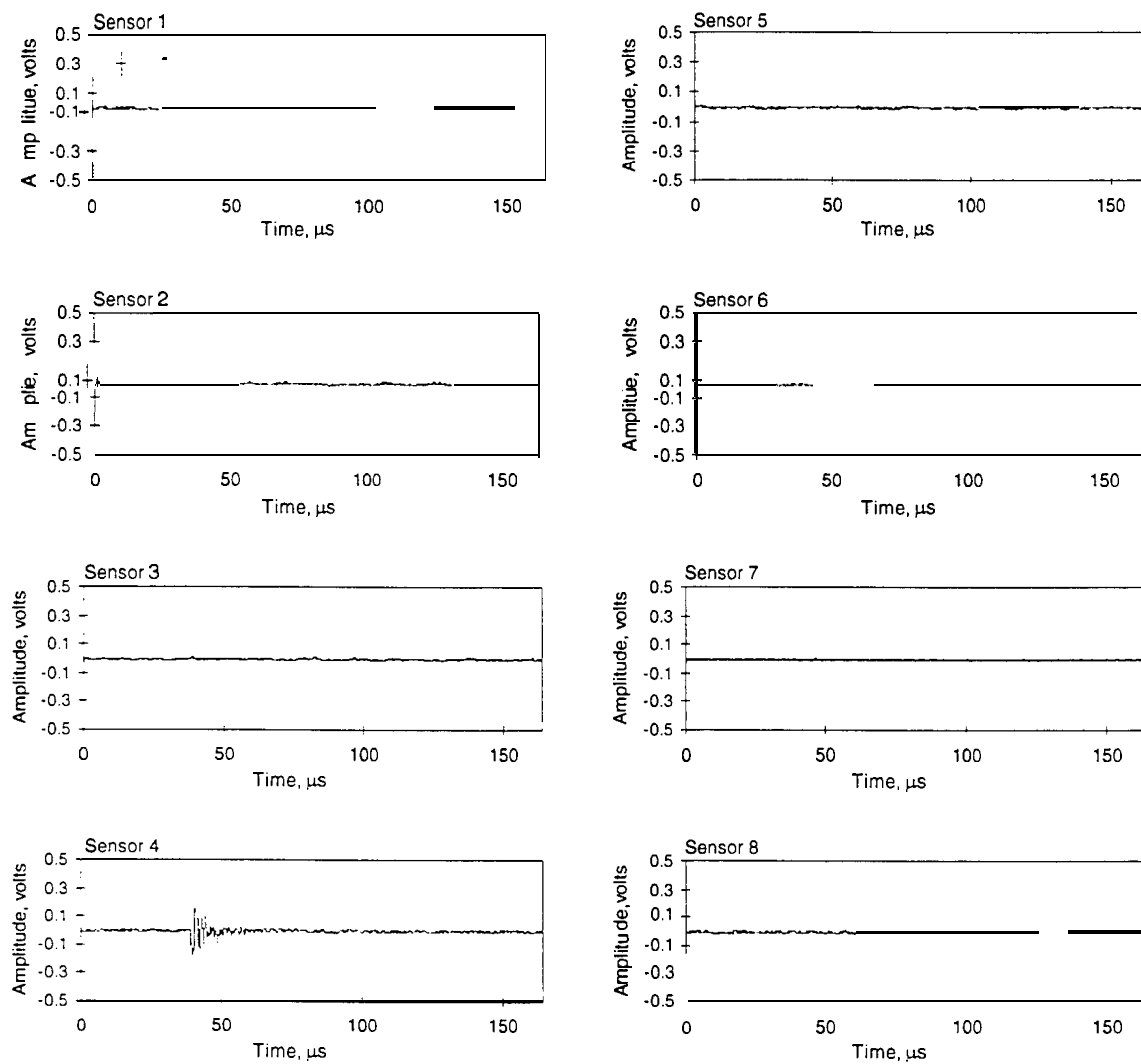
During fatigue testing of the Type 4 tank, two types of signals were recorded. The small amplitude signal from sources all over the tank is shown in Figure 96. These signals were likely produced by small cracks in the matrix. The signals that originated in the damaged area of the tank, which are likely from matrix cracking, are shown in Figure 97. On single channels, a few high frequency events were recorded. These events were similar to those seen during tow testing and attributed to fiber breakage. Just before failure of the Type 4 tank, a large increase in the number of events per cycle occurred. The majority of the events, similar to the event in Figure 97, was associated with matrix cracking in the impact damaged area. Just prior to failure, low amplitude, high frequency events, such as the waveform shown in Figure 98, were recorded.

Figure 96. Waveform from a Typical Small Amplitude Event Recorded During Fatigue Cycling of the Type 4 Tank

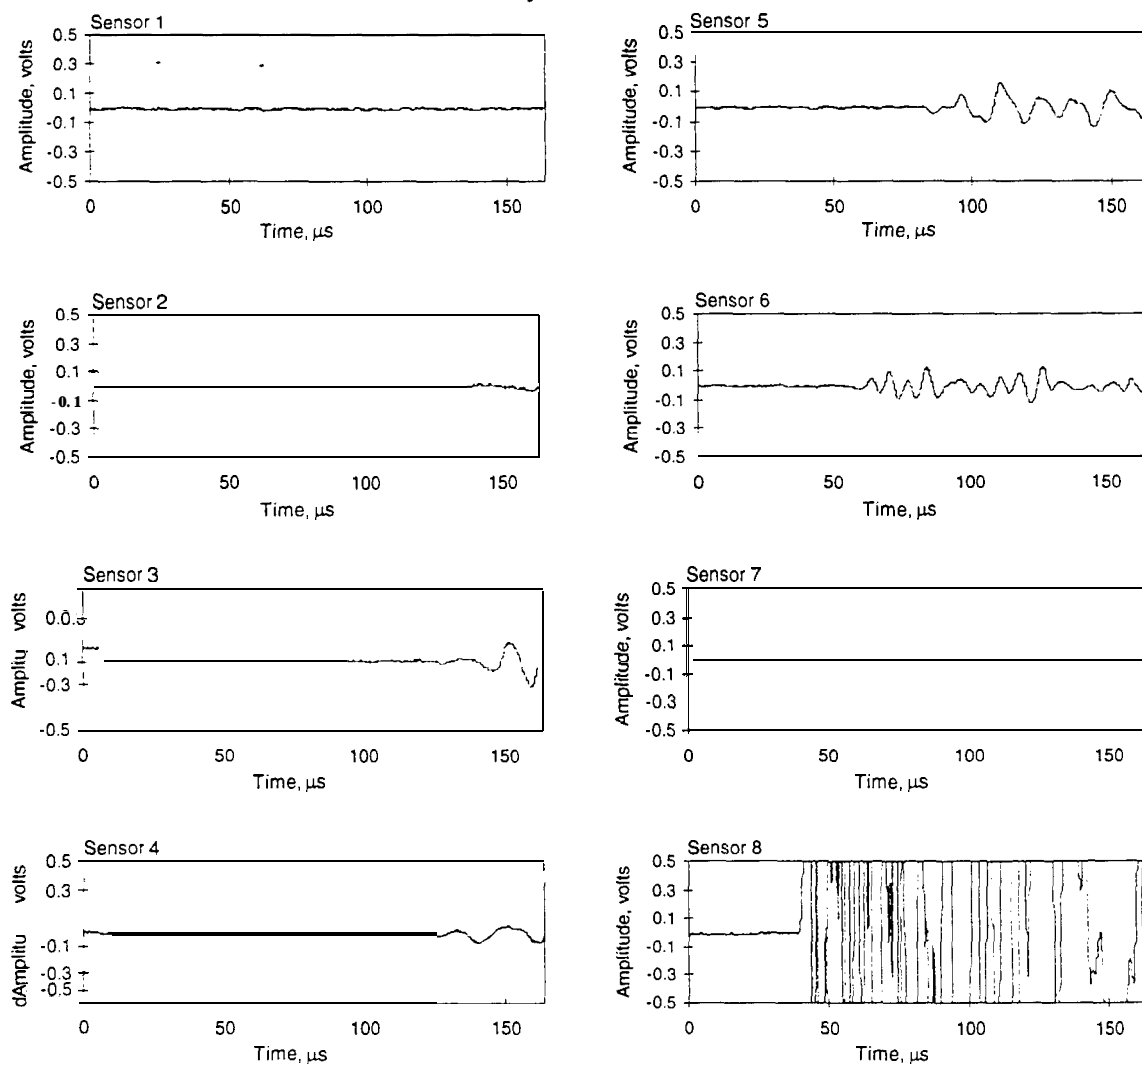
Figure 97. Waveform from a Typical Event from the Impact Area Recorded During Fatigue Cycling of the Type 4 Tank

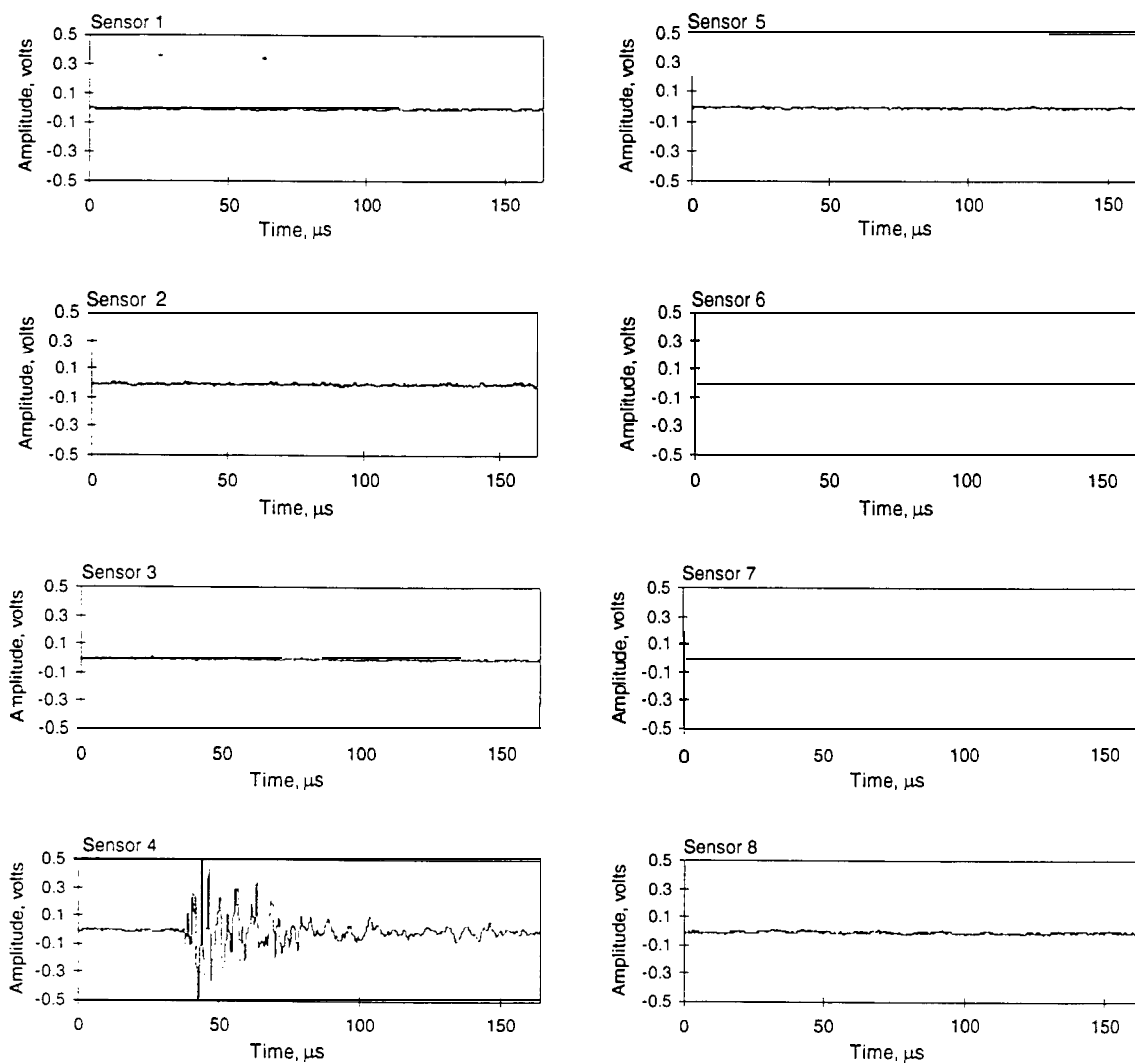
The failure of the Type 4 tank occurred at the impact site in the transition between the cylindrical section and dome of the tank. In this area, fiber orientations are changing rapidly. Much of the load is carried in shear, in which the load is transferred between fibers through the matrix and the fiber-matrix interface. Therefore, behavior of the tank in this area is very matrix dependent. The presence of acoustic emissions characteristic of matrix cracking during fatigue testing of the tank was not surprising. The absence of high amplitude, fiber breakage signals was somewhat surprising, because catastrophic failure of the tank during fatigue testing must have necessarily included fiber breakage. Some indication of fiber breakage was seen in the acoustic emission data? such as the waveform shown in Figure 98. This low amplitude, high frequency signal is similar to those observed in the tow tests. The heavily damaged area of the tank may have attenuated or prevented the propagation of high amplitude signals associated with fiber breakage, which may explain why these high amplitude signals were not recorded just prior to failure.

Figure 98a. Waveform from a Typical Small Amplitude, High Frequency Event Just Prior to Failure of the Type 4 Tank

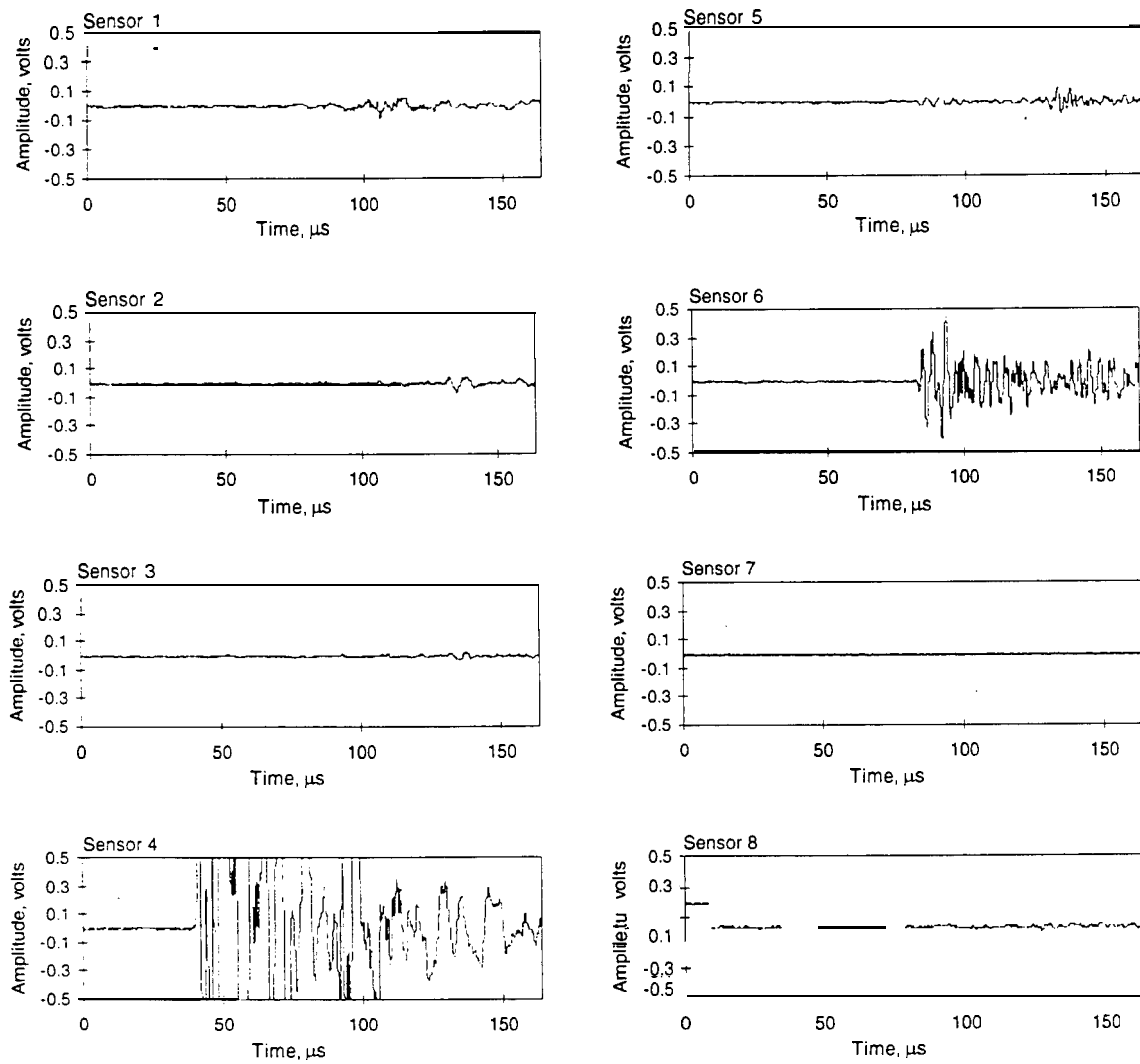
After each set of 3,000 pressure cycles, tanks were pressurized to 4,500 psig and held at that pressure for 100 seconds. A typical waveform generated in a Type 2 tank during a pressure hold is shown in Figure 99. Waveforms recorded under these constant pressure conditions were similar to the waveforms recorded from damaged tanks (Section 6.3.2). For Tank 013, a plot of the number of acoustic emission events versus time following 6,000 pressure cycles is shown in Figure 100. This plot is typical of the response of Tank 013 during the pressure holds.

Figure 99. Waveform Recorded During Pressurization Hold After Fatigue Cycling of a Type 2 Tank

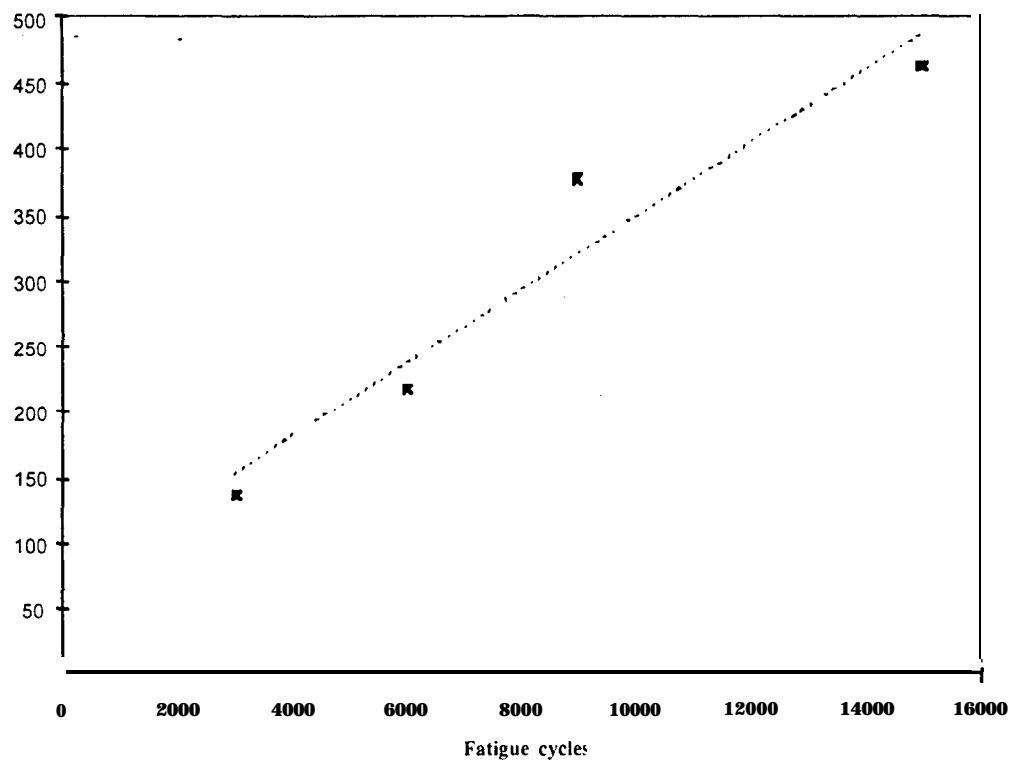
Figure 10 1. Number of Events During Each Pressure Hold After Fatigue Cycling of Tank
013

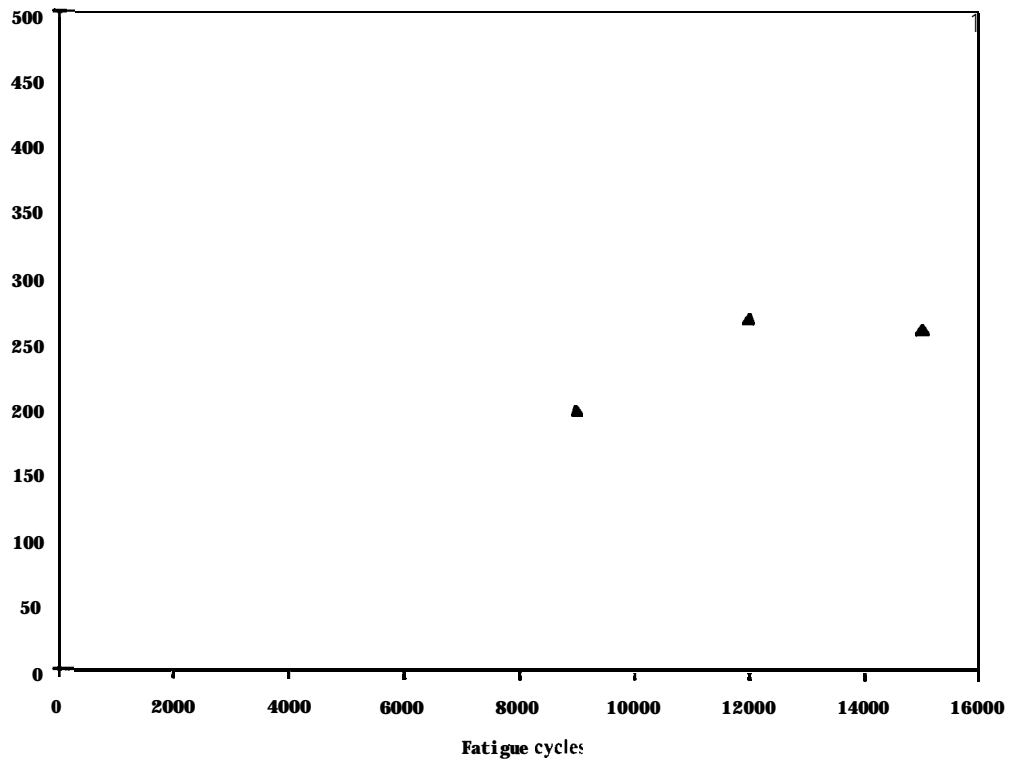
For Tank 018, a plot of the number of acoustic emission events during pressure holds versus the number of fatigue cycles is presented in Figure 102. Data for 3,000 cycles is missing, because the high rate of acoustic emission events saturated the A/D boards. The remaining data points in Figure 102 approximate a constant number of events with fatigue cycles. This response may be explained by the physical condition of the tank caused by propagation of the slit during pressurization. Visual examination of the tank early in the fatigue testing revealed that the hoop cracks from the ends of the slit and the delamination under the slit had propagated around the entire circumference of the tank. Consequently, the band of material associated with the slit was completely separated from the underlying liner and from the adjacent over-wrap. Therefore, no further damage and associated acoustic emission would occur during subsequent pressure cycling. The recorded acoustic emission events may be from the portion of the overwrap on either side of the slit, which was still bonded to the liner.

Figure 102. Number of Events During Each Pressure Hold After Fatigue Cycling of Tank 018

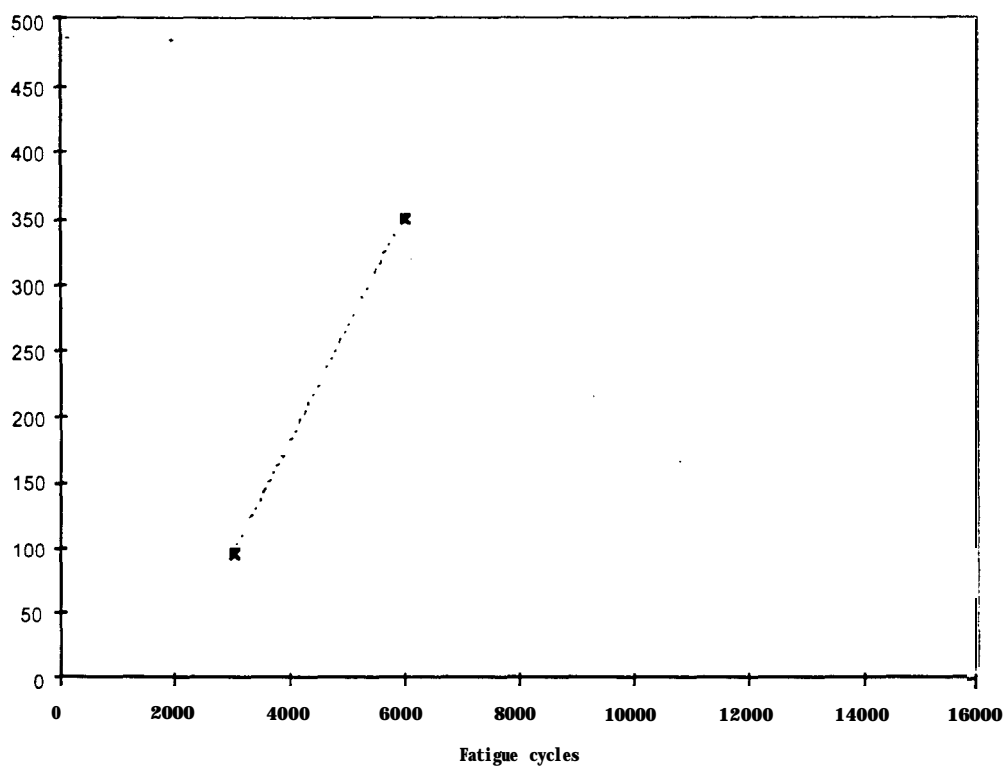
For Tank 003, the Type 4 tank, a plot of the number of acoustic emission events during pressure holds versus the number of fatigue cycles is shown in Figure 103. Data were obtained following 3,000 and 6,000 pressure cycles before the tank failed. The number of events at pressure hold increases with fatigue cycles, as it did in Tank 013. However, the rate of increase is much greater for Tank 014. This acoustic emission response is consistent with the progressive failure exhibited by Tank 014, leading to catastrophic failure of the tank during fatigue testing.

Figure 103. Number of Events During Each Pressure Hold After Fatigue Cycling of Tank 003
